# Investigation of Mitigation and Detection Methods of Open Phase Conditions (OPCs) in Nuclear Power Plants based on the Operating Experience

Minor Dissertation Presented for the Degree of:

**MEng Nuclear Power**

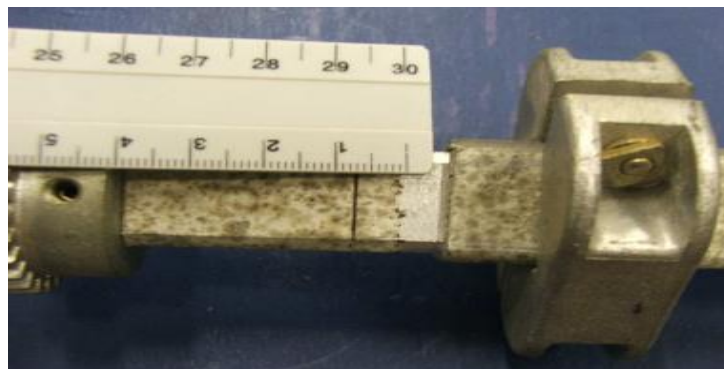
Figure 4-5 Red phase bus section 1A isolator displaced shaft [41]

After investigation it was found that there was a shaft displacement (clean area see Figure 4-5). The open circuit on the SF<sub>6</sub> isolator was not sensed by the protection relays. The procedure states that the isolators must be confirmed to be in the closed state before continuing with switching [2]. During the analysis of the incident, it was concluded that if the operators performed a “risk of trip” assessment the incident could have been averted. In order to pick up these types of defects, the SF<sub>6</sub> isolator circuits need to be manually checked before switching takes place.

The Open phase condition occurred due to the switching taking place in the 400 kV GIS switchyard that revealed a latent defect on the red phase isolator on the 400 kV Bus section 1A. The latent defect occurred because there was an open circuit in the isolator terminals of that phase, due to deformation of the isolator material [33] and the shaft was displaced out of its housing. The following also contributed to the root cause:
